# *A+ Home Inspection*

## Property Inspection Report

4321 Main St, Somewhere, IL 60123  
Inspection prepared for: John Doe  
Date of Inspection: 1/24/2013  
Age of Home: 25

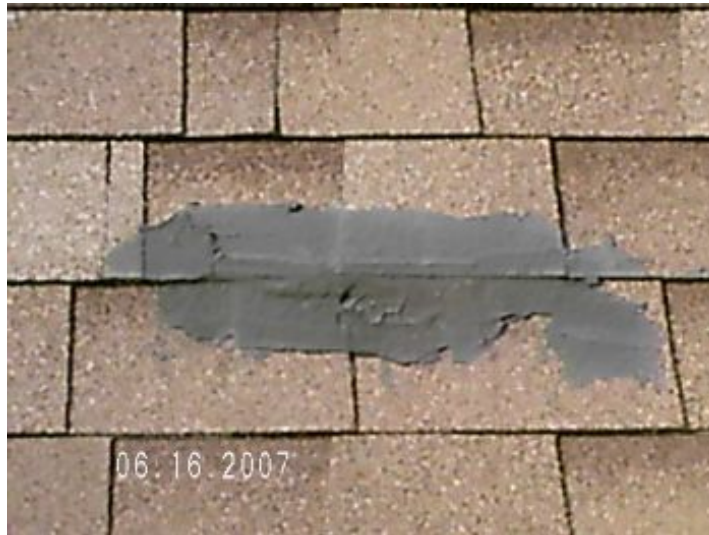
- INFORMATION - Patching is present. In my opinion this is considered a temporary repair. Patching suggests previous leakage or other problems and an attempt to correct. It may or may not hold up, its effectiveness is unknown. An annual inspection should be performed and repaired as needed. Leakage may occur.

INFORMATION - Patching is present. In my opinion this is considered a temporary repair. Patching suggests previous leakage or other problems and an attempt to correct. It may or may not hold up, its effectiveness is unknown. An annual inspection should be performed and repaired as needed. Leakage may occur.

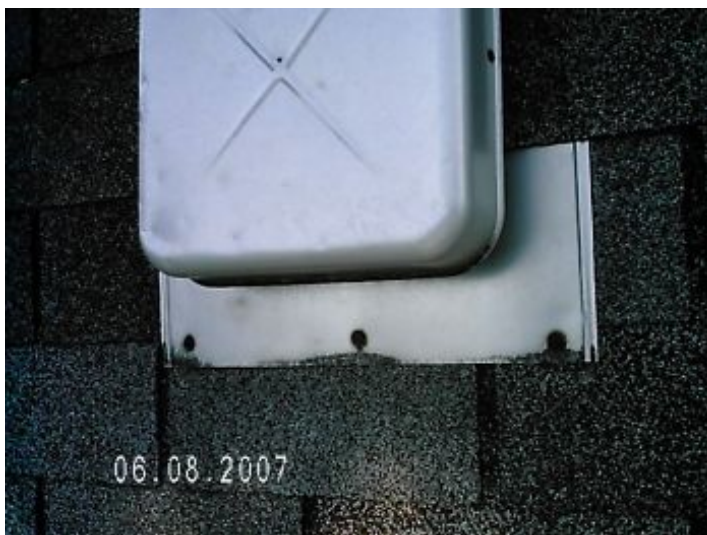
Observations:  
 • REPAIR or REPLACE - Nail heads are showing. As a rule of thumb, there should be no visible nail heads. In my opinion this can lead to water leakage and water entry into the building. Water leakage can result in significant damages I recommend you contact a qualified roofing contractor to mitigate the situation.

REPAIR or REPLACE - Nail heads are showing. As a rule of thumb, there should be no visible nail heads. In my opinion this can lead to water leakage and water entry into the building. Water leakage can result in significant damages I recommend you contact a qualified roofing contractor to mitigate the situation.

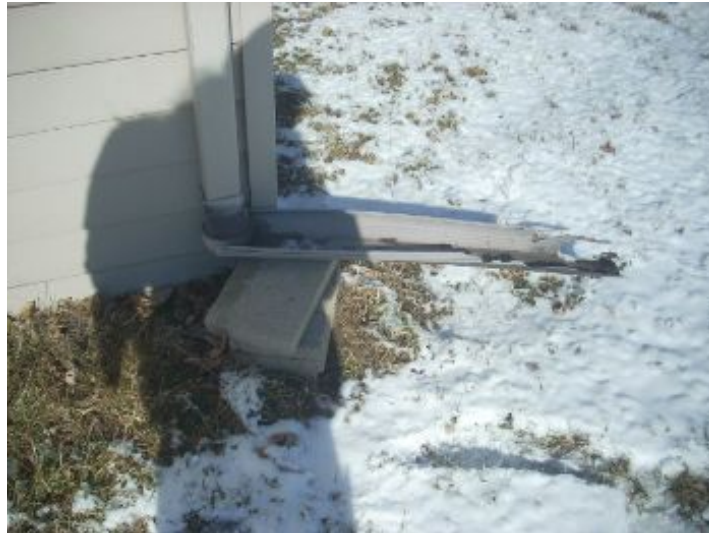
- **REPAIR or REPLACE** - The downspout discharge drains close to the house. As a rule of thumb, a minimum drainage of six feet from the house is recommended. In my opinion when drainage is closer than 6 feet there is an increased potential for water to go back to the foundation and result in water leakage into basements and crawl spaces. Water leakage can cause various problems and damage including damaging drywall, plaster, paneling, flooring and similar. Water leakage can also lead to mold problems. I recommend that you contact a qualified contractor to mitigate the situation if possible.

**REPAIR or REPLACE** - The downspout discharge drains close to the house. As a rule of thumb, a minimum drainage of six feet from the house is recommended. In my opinion when drainage is closer than 6 feet there is an increased potential for water to go back to the foundation and result in water leakage into basements and crawl spaces. Water leakage can cause various problems and damage including damaging drywall, plaster, paneling, flooring and similar. Water leakage can also lead to mold problems. I recommend that you contact a qualified contractor to mitigate the situation if possible.

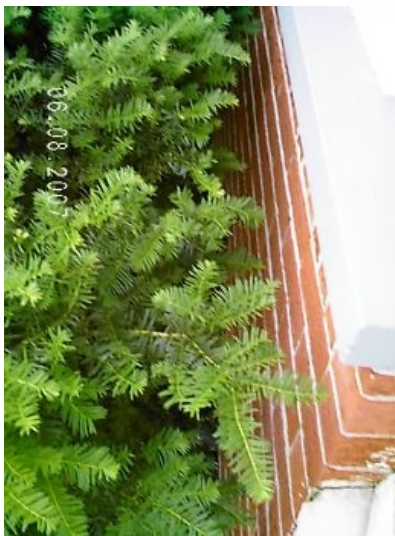
- The overall condition is acceptable.
- MAINTENANCE - Bushes are touching the building. In my opinion this can lead to insect and water damage to the building. I recommend that you contact a qualified landscaping contractor to mitigate the situation.

MAINTENANCE - Bushes are touching the building. In my opinion this can lead to insect and water damage to the building. I recommend that you contact a qualified landscaping contractor to mitigate the situation.

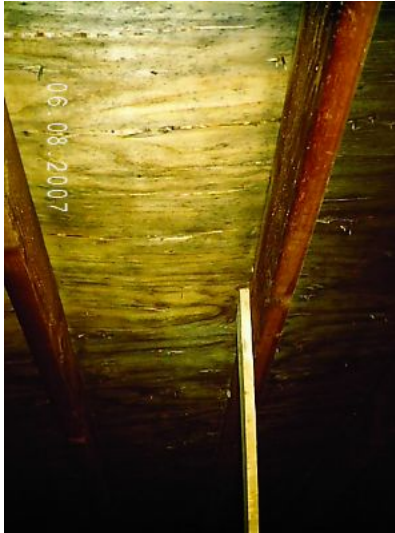
**Observations:**  
 • **REPAIR or REPLACE** - Signs of condensation is present in the attic. This may be caused by inadequate ventilation and/or insulation. Appropriate corrective action is recommended by a qualified contractor familiar with sciences involving attic spaces.

**REPAIR or REPLACE** - Signs of condensation is present in the attic. This may be caused by inadequate ventilation and/or insulation. Appropriate corrective action is recommended by a qualified contractor familiar with sciences involving attic spaces.

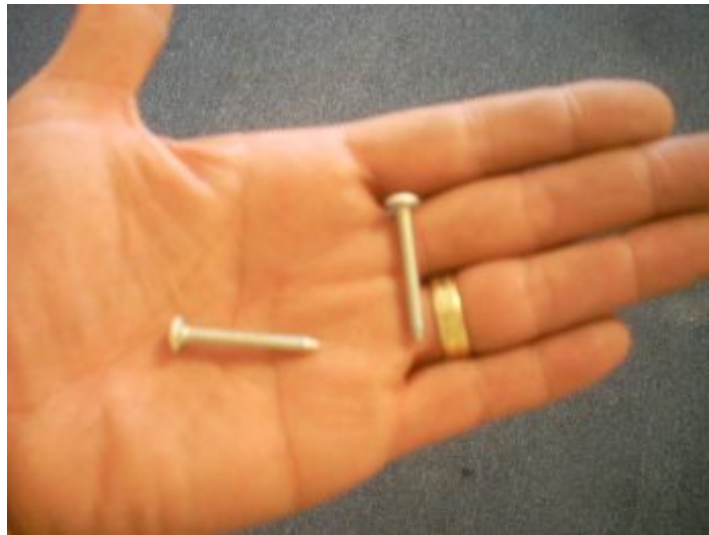
- The overall condition is acceptable.
- **SAFETY** - The panel cover is lacking appropriate screws to hold the cover on. Improper screws such as pointed tip sheet metal screws or screws missing pose certain safety hazards. Installation of proper screws is recommended by a qualified electrician.

**SAFETY** - The panel cover is lacking appropriate screws to hold the cover on. Improper screws such as pointed tip sheet metal screws or screws missing pose certain safety hazards. Installation of proper screws is recommended by a qualified electrician.

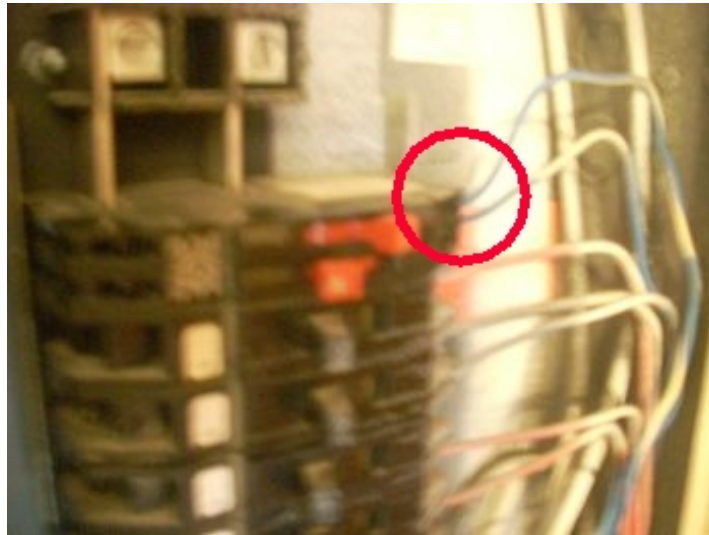
- **SAFETY** - There is double tapping at the circuit breakers (or fuses). This is considered improper and potentially unsafe. Corrective action is needed by qualified electrician.

**SAFETY** - There is double tapping at the circuit breakers (or fuses). This is considered improper and potentially unsafe. Corrective action is needed by qualified electrician.

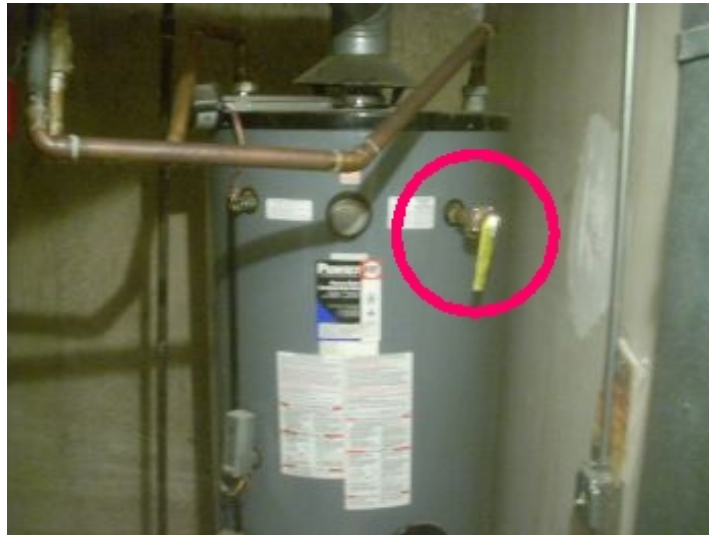
Materials: Conventional Gas Fired • 5 - 10 years old  
 Observations:  
 • SAFETY - The temperature / pressure relief valve (TPR) is an important safety feature and can prevent explosions in the event of a malfunction. The TPR valve extension pipe is too small (wrong size) and may not be able to safely discharge water in the event of an emergency or malfunction. In my opinion this is an explosion hazard and properly sized & installed extension pipe is needed by a qualified contractor.

**SAFETY** - The temperature / pressure relief valve (TPR) is an important safety feature and can prevent explosions in the event of a malfunction. The TPR valve extension pipe is too small (wrong size) and may not be able to safely discharge water in the event of an emergency or malfunction. In my opinion this is an explosion hazard and properly sized & installed extension pipe is needed by a qualified contractor.
